# Manhole Inspection Summary

Manhole # S13GG2012MH

Insp Date: **7/5/06 11:34 AM**

**Location** Address: **2105 SOUTHCLIFF DR**

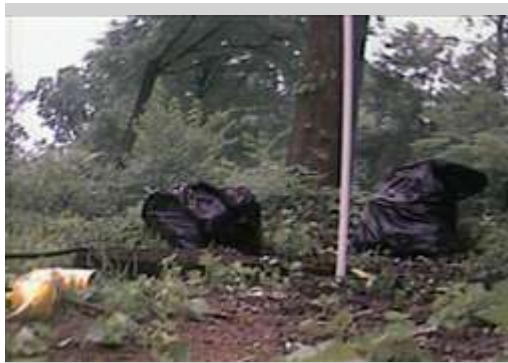
Location View

Comments **In back yard of 2105 Southcliff Drive.**

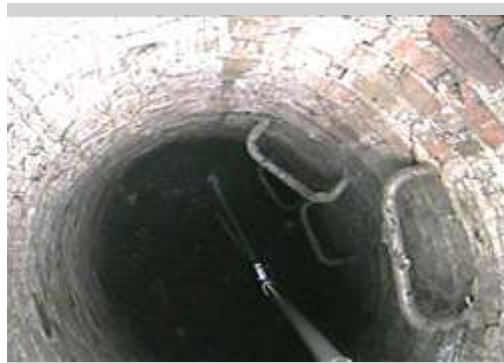
Top View

Condition: ☐ Sound ☐ Cracked ☐ Root Intrusion ☐ Loose Brick ☒ **Deteriorated**

Infiltration: ☐ None ☒ **Joint** ☐ Cracks ☐ Mortar ☐ Roots ☒ **Wall**

Infiltration: ☐ None ☐ Joint ☐ Cracks ☒ **Mortar** ☒ **Roots** ☒ **Wall**

Corbel deterioration and infiltration. Barrel infiltration. Channel debris.

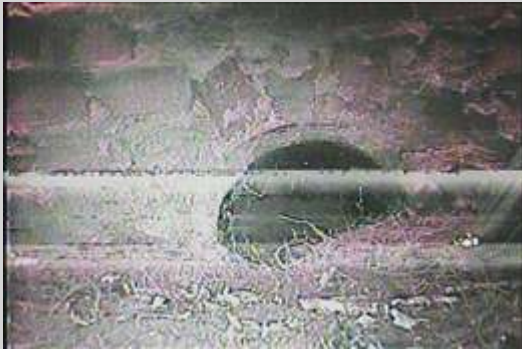
8 in. Circular Gravity Sewer  
Pipe Out @ 12 O'Clock

Condition: ☐ Sound ☐ Cracked ☒ **Root Intrusion** ☐ Loose Brick ☒ **Deteriorated**

Barrel deterioration, root intrusion and infiltration.

Deposits: ☐ None ☒ **Mud** ☐ Sludge ☒ **Debris** ☐ Grease

Silt Depth: **2** (in.) Deposits Extent: **Light**
